**MULTI-SECTORAL DETAILED NEEDS ASSESSMENT REPORT ON FLOODS IN  
KARONGA DISTRICT, MALAWI**

February 2024

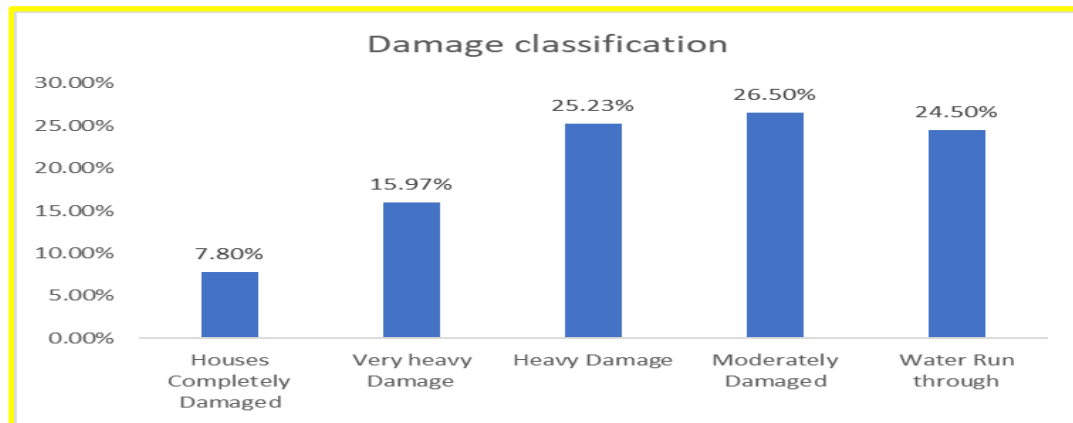
Figure 4: Percentages of damage classification

The table below illustrates different damage classifications for houses, with the majority of the damaged houses falling into moderately damaged at 26.50 %, Heavy damaged at 25.23 % while House completely damaged is at 7.80 %. Most of the affected people in the camps according to the findings of the assessment and observation are those falling under very heavy damage to moderate, hence shelter needs are of great importance in the affected GVHs for the people to go back and rebuild their homes.

All the 270 households with shelter damage classification ranging from completely damaged to very heavy damage may require assistance so that they may be able to build back their houses. A CVA response option may be a required option to help the survivors and also in kind depending on the availability of the shelter materials. But the HHs may be filtered further based on the available resources.
