Mozambique: Cyclone Idai - results and analysis of aerial survey as of 29th March 2019

MA023 v09

MOZAMBIQUE - TC IDAI Aerial Assessment Report

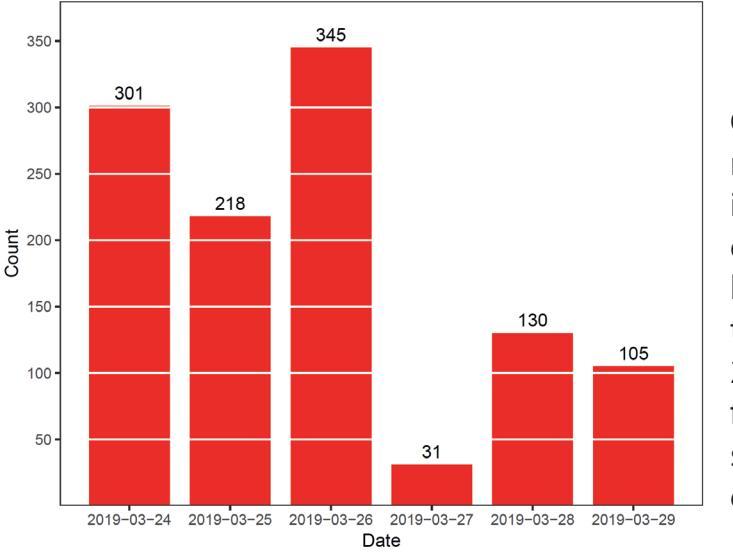
TIMELINE

Chart displays number of points of interest recorded each day, with ³/₄ being collected over the first three days, 24-26 March, when floodwaters were still near their highest point

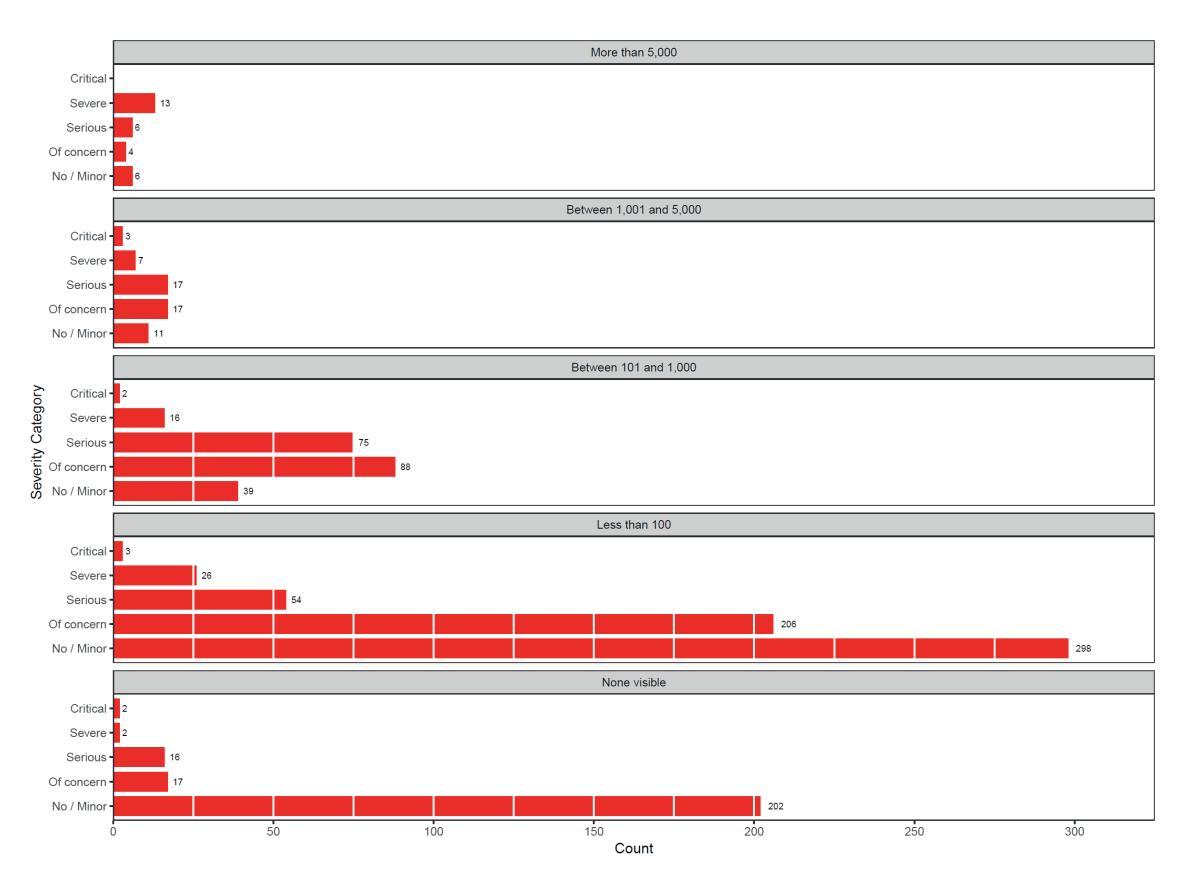
Comparison of severity category against estimated population

Chart shows the distribution of severity across estimated population of the point of interest.

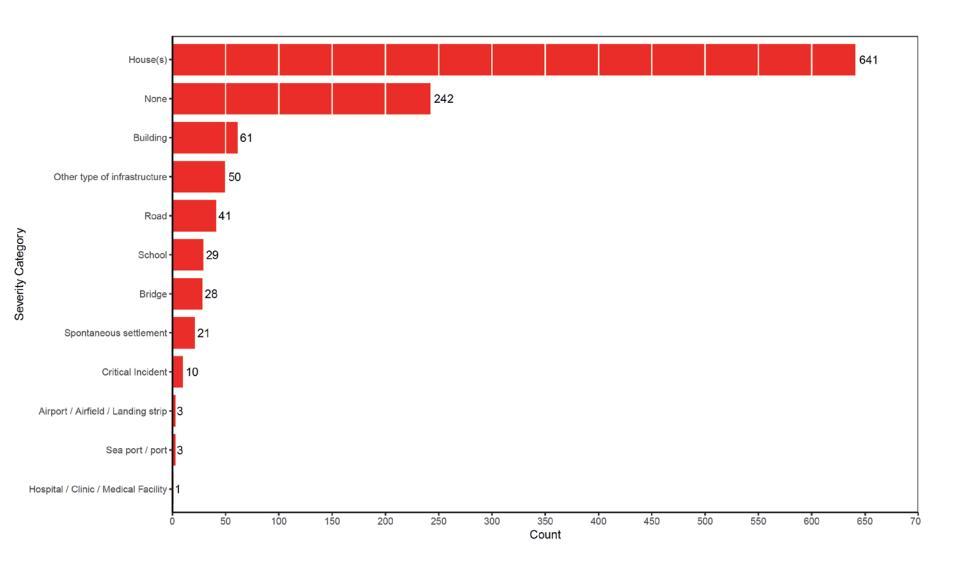
Number of points of interest collected for each point of interest

Chart shows the distribution of points of interest across the different categories, with the majority of points collected being houses / communities

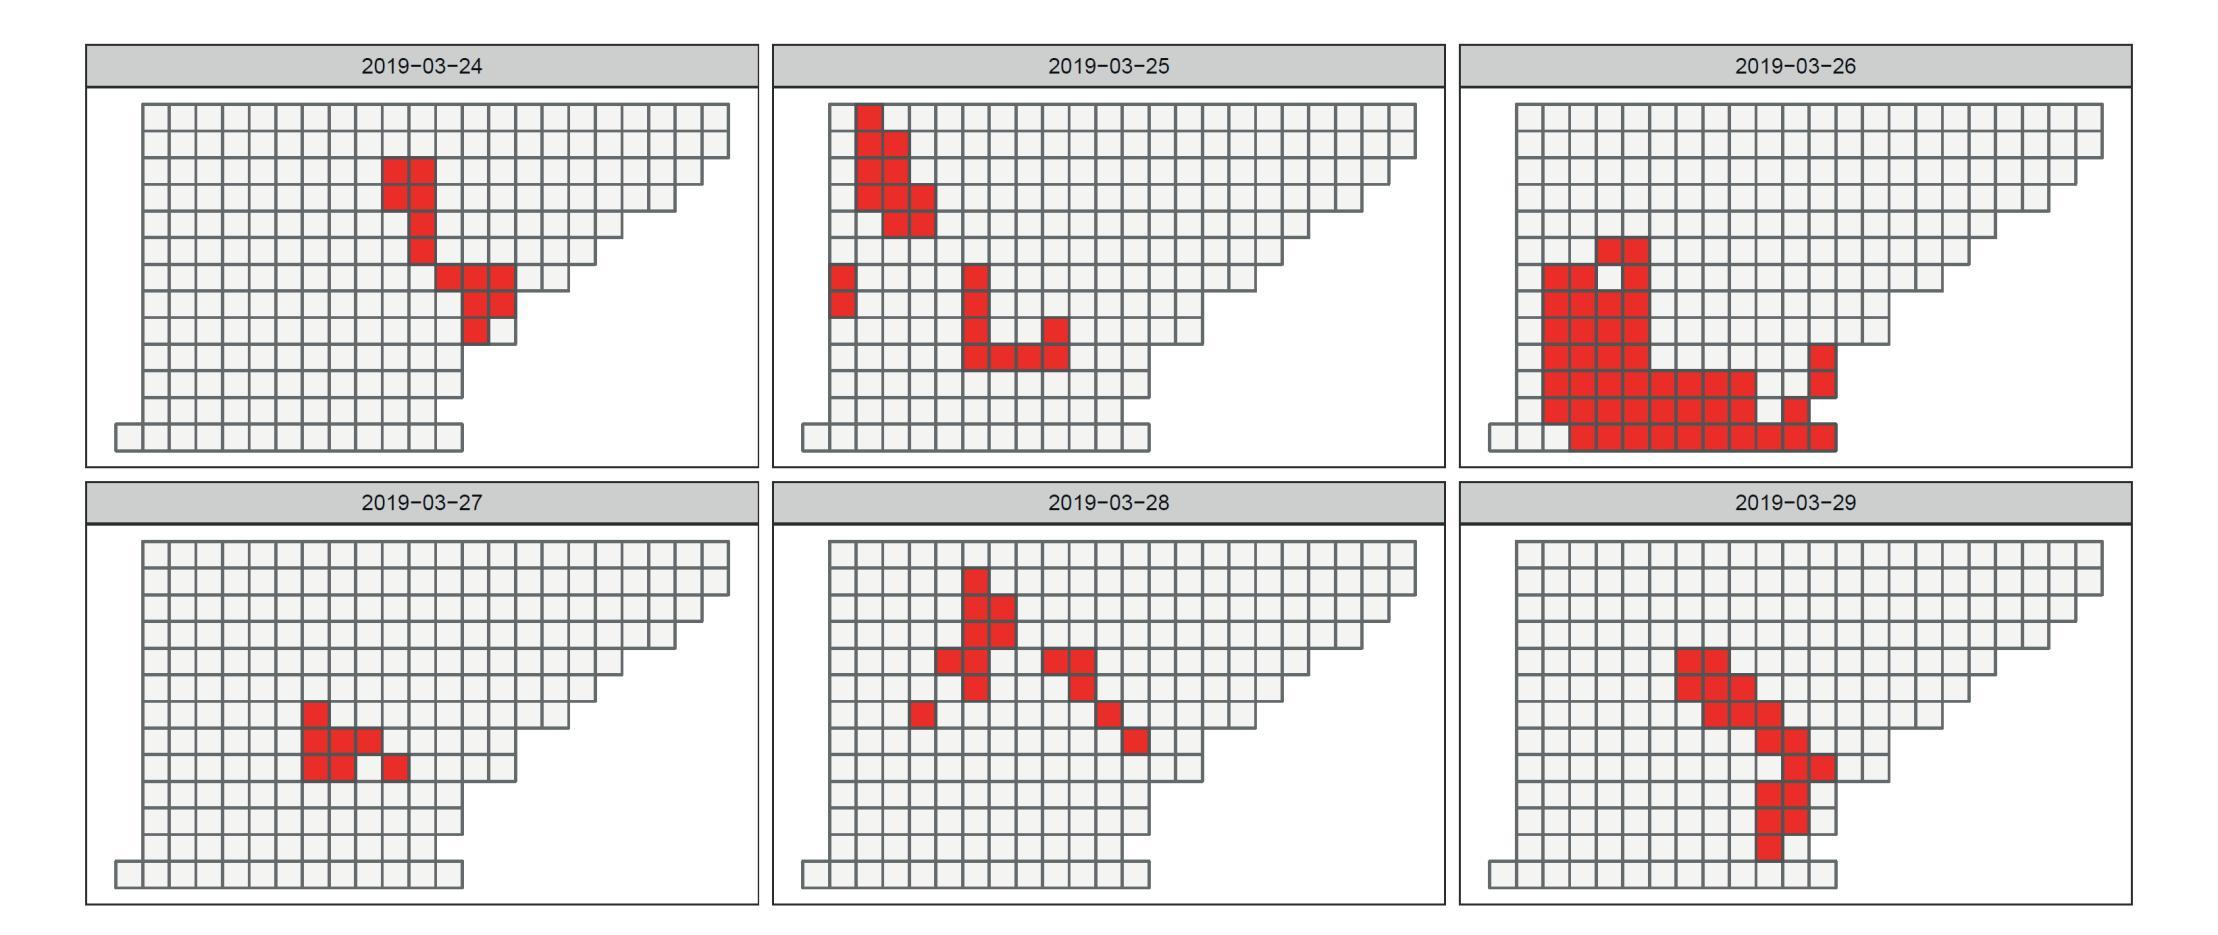
TIMEFRAME

Graphic shows the prioritisation of aerial assessment according to first satellite detected flood waters, storm track and then comprehensiveness
